# Alert to any alarms

The New Zealand Fire Service keeps a close eye on emerging fire risk and has identified some building products and practices that are potentially dangerous and should be avoided.

BY KARLUM LATTIMORE, SENIOR COMMUNICATIONS ADVISOR, NEW ZEALAND FIRE SERVICE

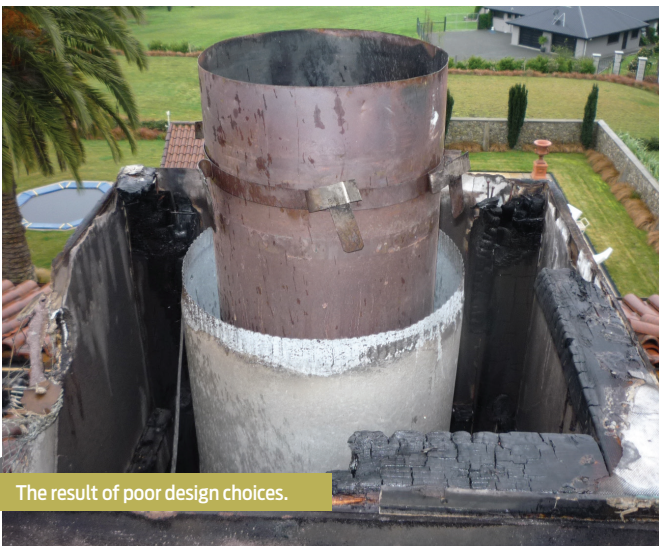
The result of poor design choices.

‘Builders had put a timber frame with cement or hardboard cladding around a metal flue as it emerged from the roof of a house,’ says Peter Wilding. ‘The products they used should have been non-combustible or adequately separated from the heat source and should also have had adequate ventilation at the top and bottom.’

Timber framing directly under the flashing was the starting point for two fires in Blenheim. The timber was subjected to prolonged heating, and over time, this pyrophoric action significantly reduced the ignition point. A chimney fire was inevitable.

Building inspectors need to be aware of the danger of non-compliant design and construction and the need for adequate ventilation.
