# Stable foundations

Stable foundations are important for all buildings to keep them from sinking, or tilting like the leaning tower of Pisa!

By Nigel Isaacs, BRANZ Principal Scientist and Teaching/Research Fellow, School of Architecture, Victoria University of Wellington

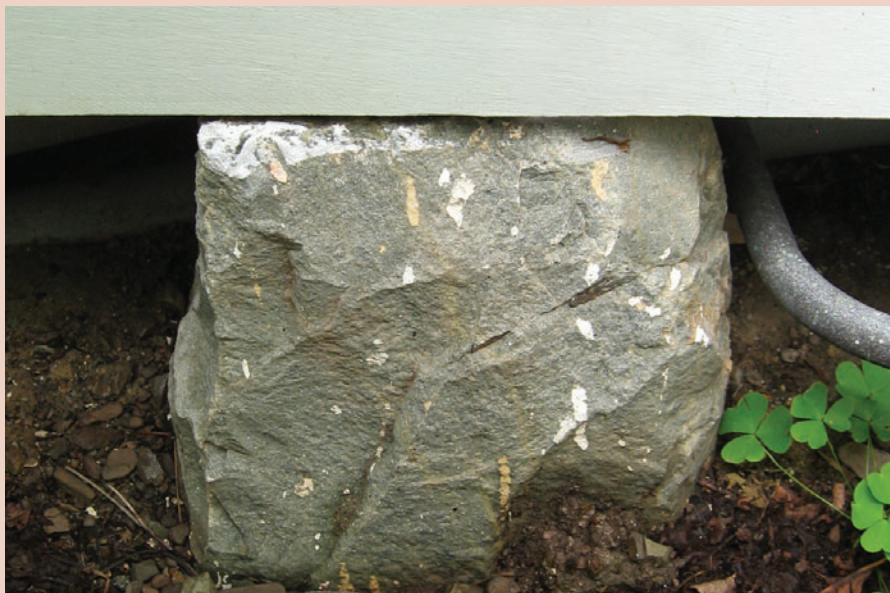
Figure 1: A shaped stone pile at Ranzau (built 1844).

New Zealand timber houses made use of a huge variety of pile materials to support the floor and superstructure. Locally sourced, shaped riverstones still support Ranzau – a house at Hope, near Nelson, built around 1844 (see Figure 1). Near Kaikoura, Fyffe House, thought to date from the mid-1840s, stands on piles made from discarded whalebone vertebrae. Timber piles only became common in later years.

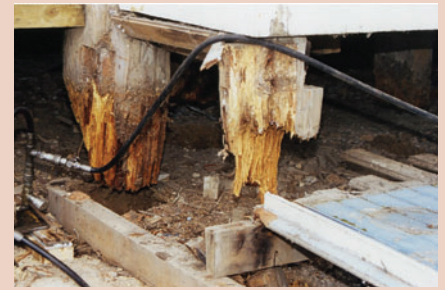
Figure 2: 90-year-old totara piles after house lifted (hydraulic pipes connecting the central pump to distributed lifting jacks are visible).

As an example, floors in parts of a 1908 house on a relatively dry site sank over 90 years until the bottom of the laundry floor joists touched the ground. When the house was lifted using hydraulic jacks, the bottom of the piles appeared as decayed, spongy wooden teeth (see Figure 2). They were replaced with modern treated timber

piles. The house was lowered back down, leaving a 400 mm air gap above the ground and with the floors levelled as far as possible – unevenness being part of the character!

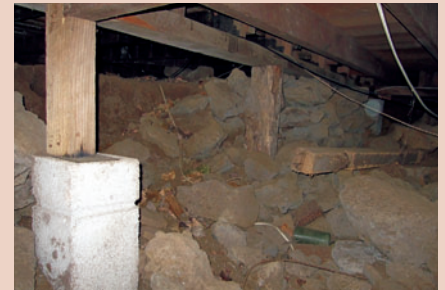
Figure 3: Today's restored Alberton (originally built 1863) with a modern timber jack stud in the foreground on top of a pre-cast concrete pile and the original timber pile with scoria wall behind.

Built in Auckland in 1863, Alberton originally stood on timber piles with perimeter support from local scoria, stacked into walls. The New Zealand Historic Places Trust renovated Alberton in the early 1970s, and timber piles were replaced with precast concrete ones and treated timber jack studs. Just one original timber pile remains (see Figure 3).
